SCHOOL GAS SAFETY CASE STUDIES

SAMPLE OF EDUCATION SECTOR SOLUTIONS

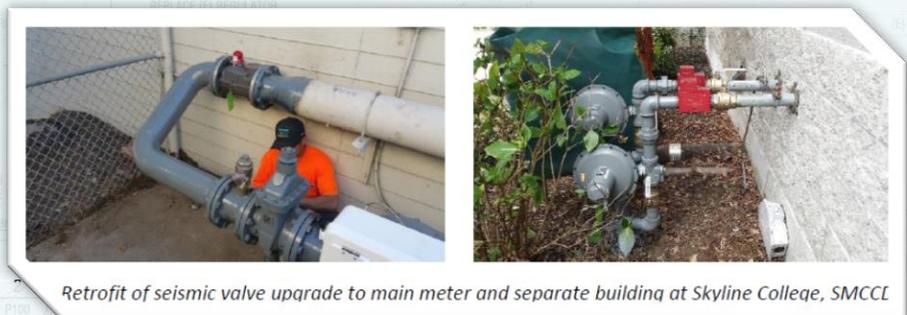
- Broken or frozen manual shut-off valves
- Regulators, broken or not properly positioned/calibrated
- Lack of seismic valve (automatic gas shut-off) protection
- Inability to isolate gas flow to a specific building for maintenance or other reason
- No manual shut-off valve
- Gas shut-off located only at the main meter

- Inspection of all manual shut-off valves to verify proper operation
- Installation of new manual shut-off valves to allow for gas shut-off at each building
- Located manual shut-off valves after regulators to reduce excessive gas pressure
- Inspection, re-calibration and replacement of regulators

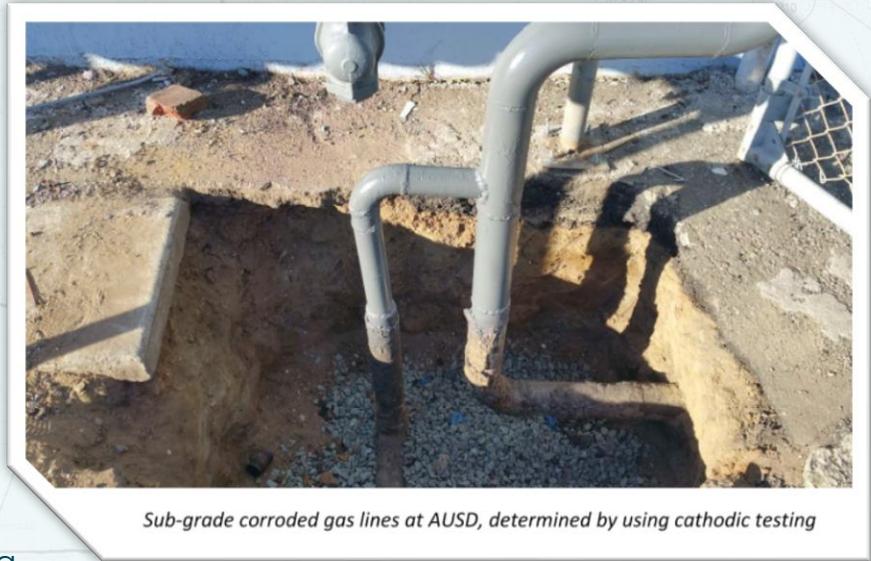
- Several of the 17 district campuses required installation of automatic gas shut-off valves
- Five campuses failed the corrosion leak detection test
- Sub-grade gas lines corroded and in poor condition
- Manual shut-off valves frozen or missing
- The main manual shut-off valve at one campus was in a locked, underground vault
- Most schools were configured with one location to shut off gas to the entire campus

- Installation of seismic (automatic) gas shut-off valves
- Evaluation of condition and calibration of campus regulators
- Replacement of ineffective, inoperable regulators
- Replacement of corroded manual shut-off valves
- Provision of method to isolate gas flow to a specific building for maintenance or other reason with additional manual shut-off valves
- Performance of cathodic testing for corrosion and leak detection
- Replacement or repair of corroded gas lines

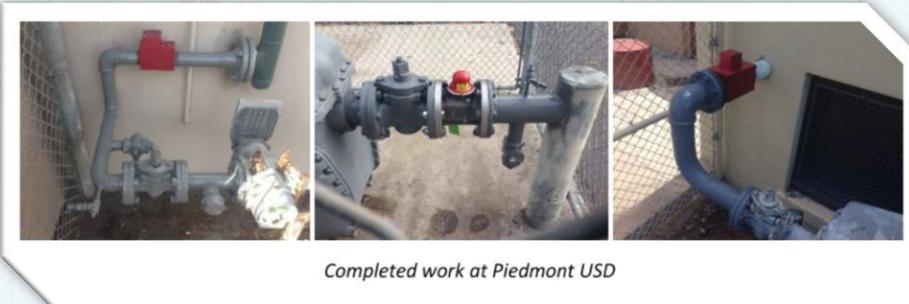
Completed work at Piedmont USD

- All seven campuses required installation of automatic gas shut-off valves
- Sub-grade gas lines at multiple schools corroded and in poor condition
- Manual shut-off valves frozen or missing
- Regulators not calibrated properly
- Most schools were configured with one location to shut off gas to the entire campus

- Inspection of all manual shut-off valves
- Installation of new, manual shut off-valves to allow for gas shut off at all buildings as-needed

- Location of manual shut-off valves after regulators
- Inspection, re-calibration and replacement of regulators
- Installation of seismic (automatic) shut-off valves at all buildings
